Manhole Inspection Summary

Manhole # S05WW1005MH

Insp Date: **9/13/06 7:52 AM**

Location Address: **3412 ROCKWOOD AVE**

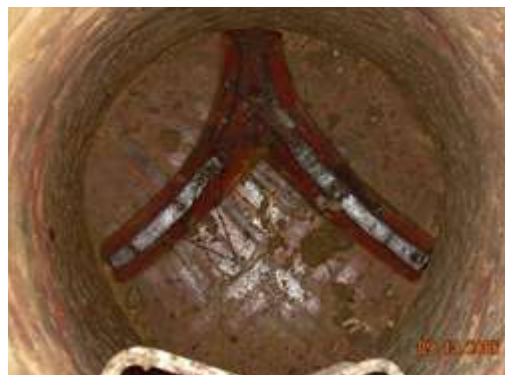
Top View

Adjustment, Corbel, and Barrel infiltration.
Evidence of surcharge - Bench debris.
Corroded steps.

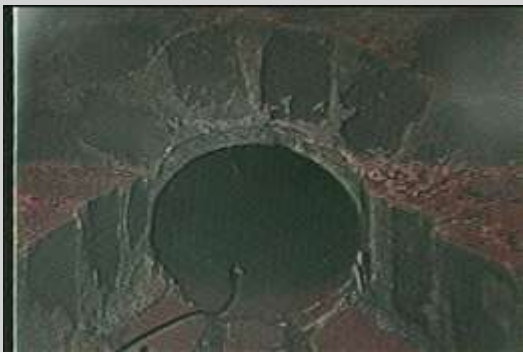
8 in. Circular Gravity Sewer Pipe Out @ 12 O'Clock

Infiltration: **Evidence** Pipe Seal Cond: **Cracked**

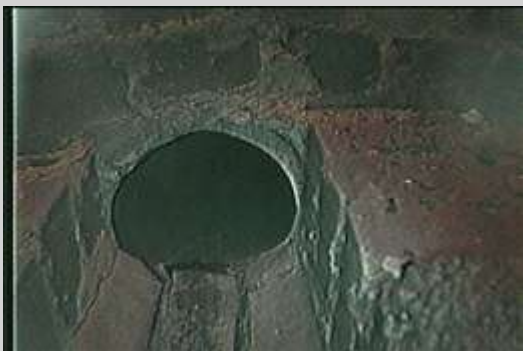
6 in. Circular Gravity Sewer Pipe In @ 4 O'Clock

Infiltration: **Evidence** Pipe Seal Cond: **Unknown**

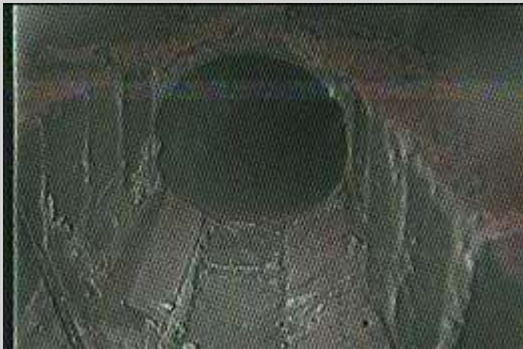
6 in. Circular Gravity Sewer
Pipe In @ 8 O'Clock

Infiltration: **Evidence** Pipe Seal Cond: **Unknown**
